Ground Stabilisation Bund Sealing

Client:
Tennants Fine Chemicals

The Project:
Ground
Consolidation

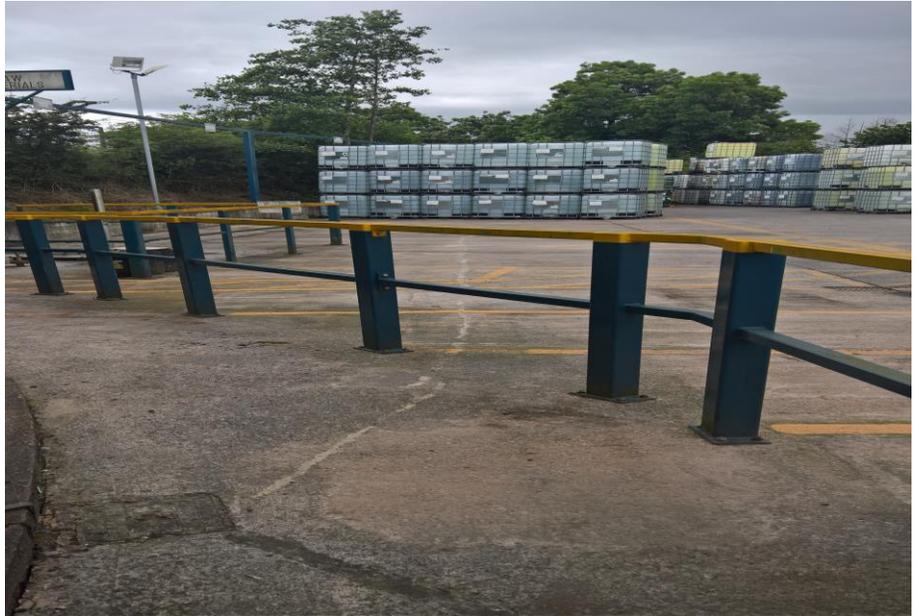
Tennants Fine Chemicals Limited commissioned a ground survey carried out by BSL to determine ground conditions beneath part of a concrete floor slab which was showing signs of stress and cracking.

The tests carried out highlighted the need for consolidating soft peaty layers, void filling as well as the need to seal the banded areas where cracks had allowed for possible migration of any spillages into the water course.

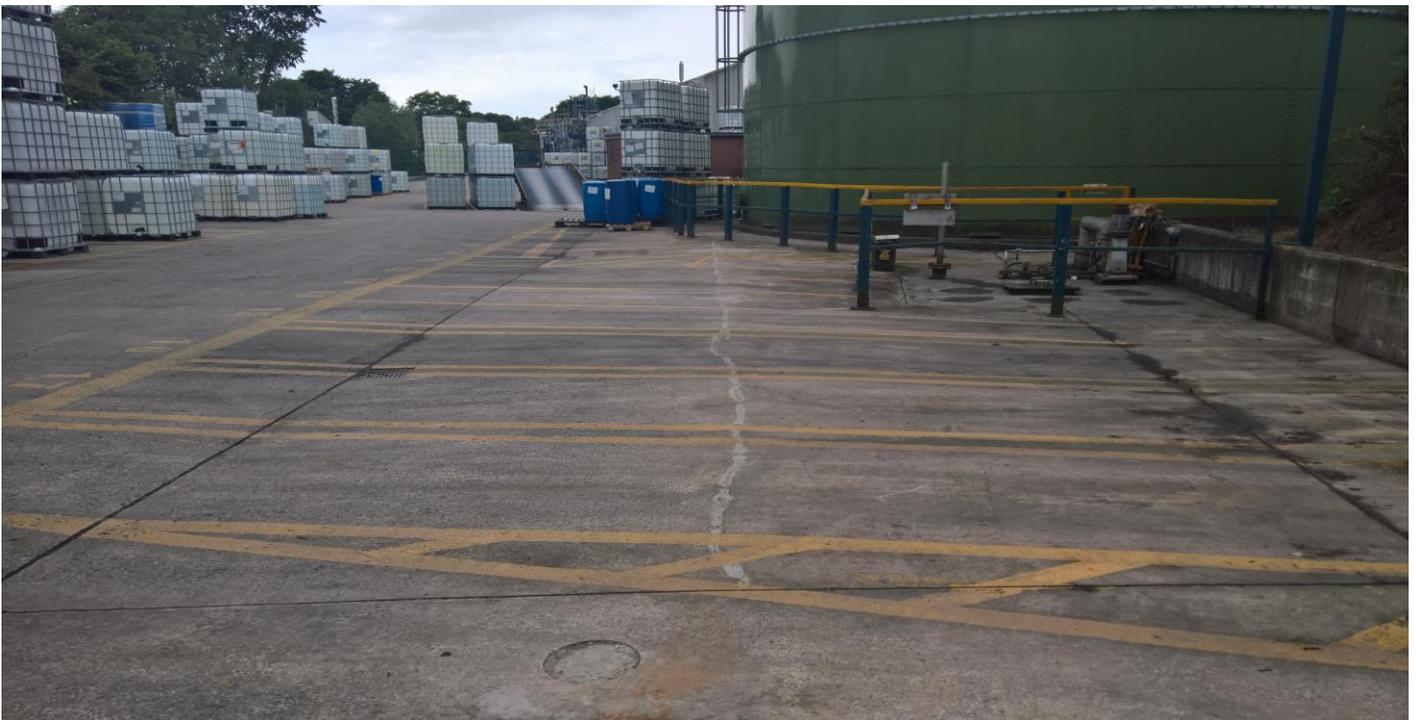
As a result of the resins low viscosity, high flexural strength and adhesive tensile strength, they can be injected into cracks of 0.25mm crack width and reach even the finest of micro-cracks through our pressure injection procedure.

This type of application enables the resins to permeate the finest of pores within the concrete thus binding the particles together.

There were added benefits of using this method of sealing the fractures with *HA Safefoam* resins and because of the resins ultra-low viscosity during the injection process we were able to concentrate the resin into the finest of micro-cracks thus displacing water from the fractures and providing a watertight seal to the bunded slab. In turn this prevents any further decay of the slab from water / chemical infiltration and frost due to the resin's ability to fill all cracks and cavities in the injection procedure.
