# RESTEK

Louth County Hospital Refurbishment

September 2016

**NHS Property Services**

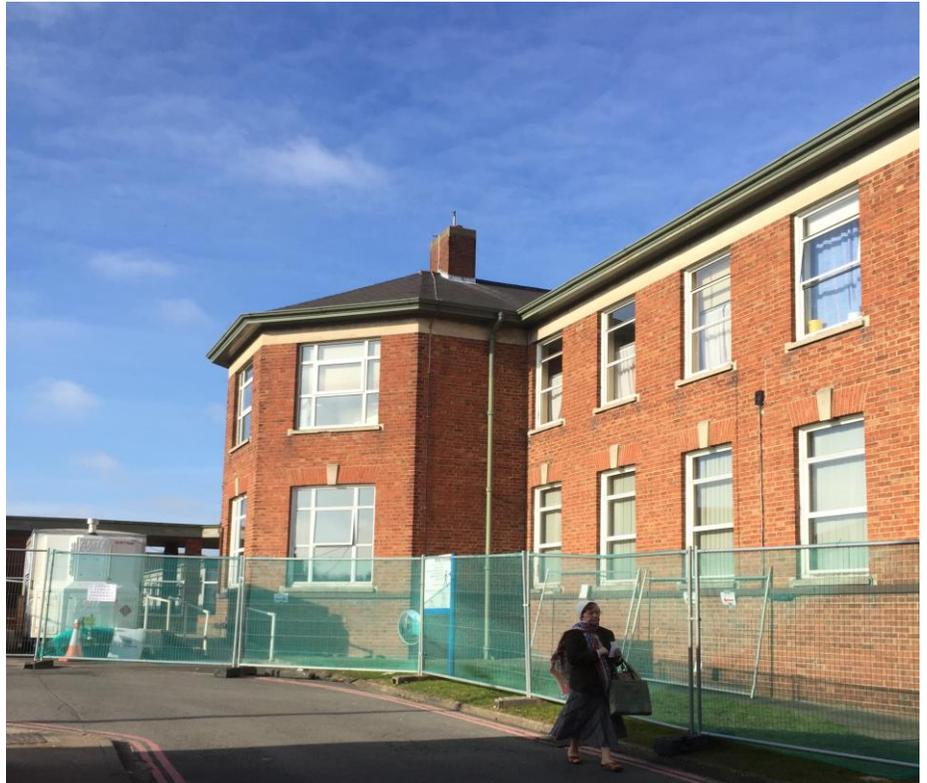
This building constructed in the 1920s with large pre-cast concrete window sills and ring beams at the top of the building was showing signs of spalling to many of the concrete sills and in some cases large pieces of concrete had begun to fall off the building posing a serious concern for the safety of both the staff and members of the public using the hospital.

**A neglected structure requiring extensive repairs and refurbishment**
