Matlock Bath Ground Stabilisation

August 2016

Subsidence

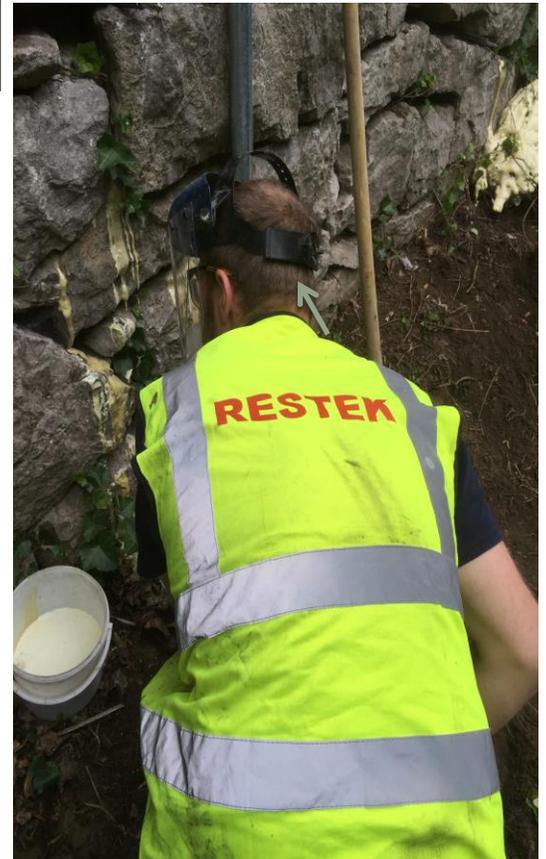
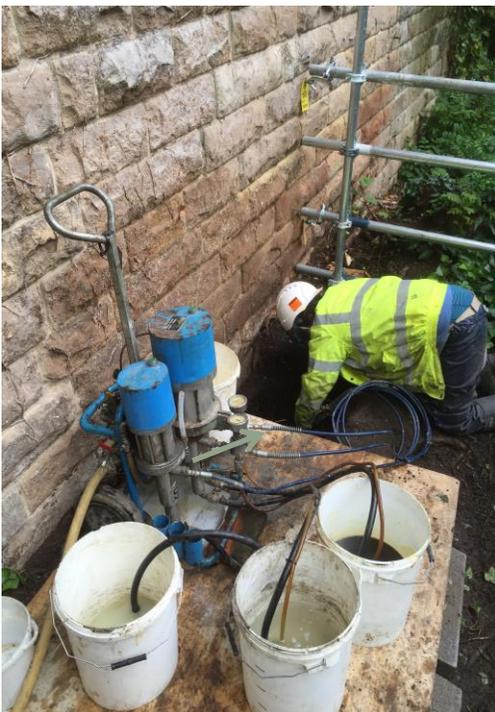
Our trial digs revealed high tree root activity causing localised subsidence and cracked masonry still visible on the external and internal walls. Loose un-compacted soils washed out behind the retaining wall likely caused from the river at high flow during the winter months.

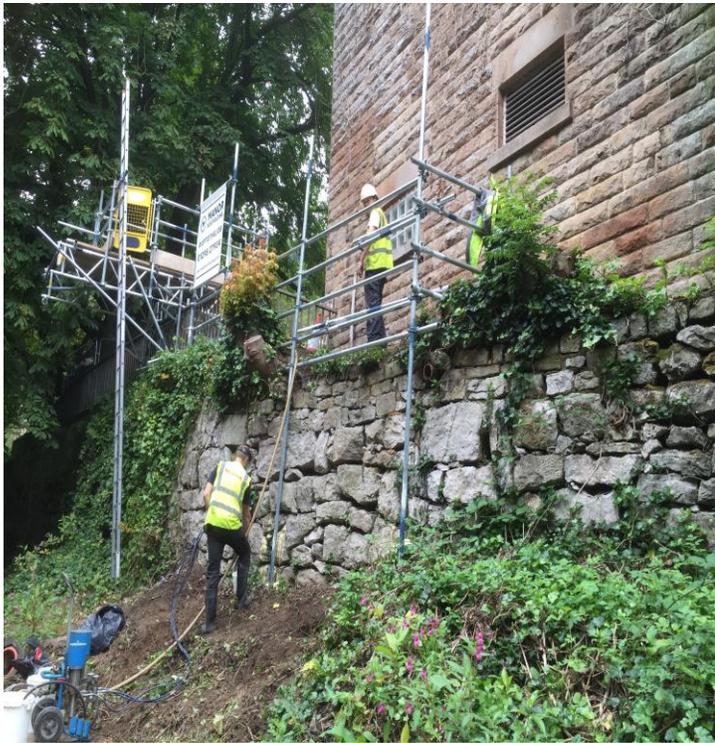
We determined that the rear corner of the building foundations had been affected by two factors

There were five locations that required stabilising via a pressure injection system with the use of our structural resin injection *Rockstab*.

We intersected the footings with a combination of injections both through the retaining wall and from ground level to the perimeter along three metres.

Based on the test foundation information, we allowed for 1,460 kilos of resin to stabilise the building to prevent further washout from loose un-compacted soils. This filled all voids below ground level and compacted the soft under laying soils to form a solid mass that both stabilised the foundations and the riverbank from further wash out.
